INDOOR AIR QUALITY ASSESSMENT

**Norton High School
66 West Main Street
Norton, Massachusetts**

Prepared by:
Massachusetts Department of Public Health
Center for Environmental Health
Emergency Response Indoor Air Quality Program
June 2005

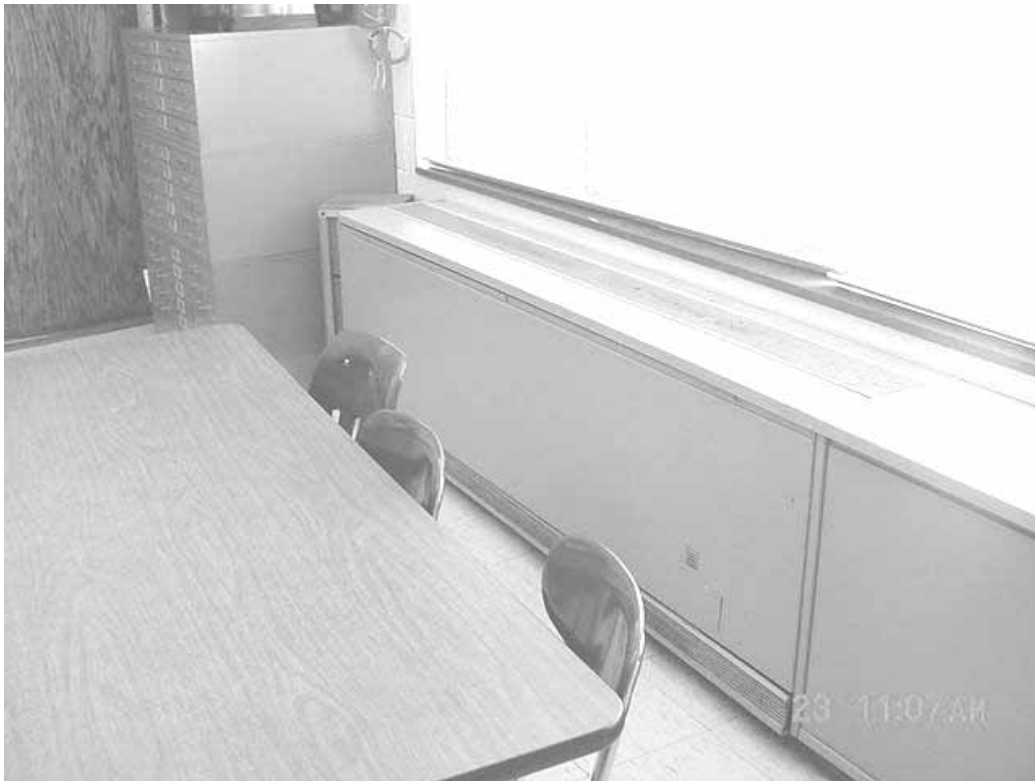
Picture 1

Fresh air in exterior classrooms is supplied by unit ventilator (univent) systems (Picture 1). A univent is designed to draw air from outdoors through a fresh air intake located on the exterior wall of the building (Picture 2). Return air is drawn through an air intake located at the base of each unit ([Figure 1](#)). Fresh and return air are mixed, filtered, heated and provided to classrooms through a fresh air diffuser located in the top of the unit. Univents appear to be original equipment, approximately 35-40 years old. Efficient function of such aged equipment is difficult to maintain, since compatible replacement parts are often unavailable. The majority of univents were operating during the assessment; however, some univents had been deactivated (Table 1). In order for univents to provide fresh air as designed, these units must remain “on” and allowed to operate while rooms are occupied.

Classroom Univent 1970's Vintage

1. Examine each univent for function. Survey classrooms for univent function to ascertain if an adequate air supply exists for each room. Consider consulting a heating, ventilation and air conditioning (HVAC) engineer concerning the calibration of univent fresh air control dampers.

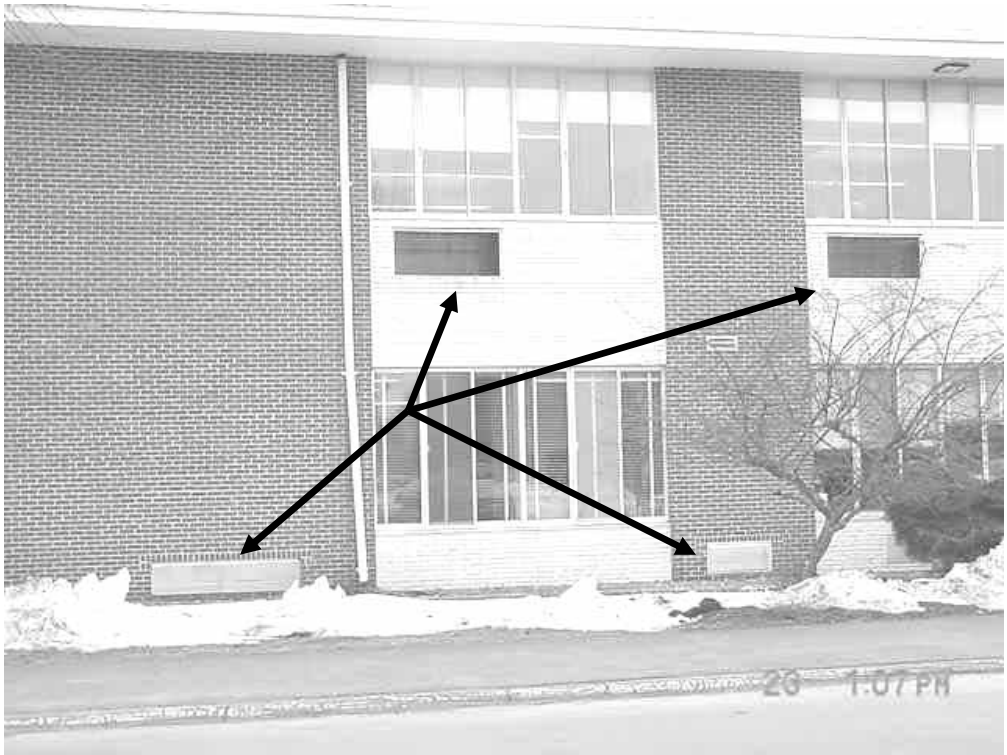
Picture 2

Univent Fresh Air Intakes

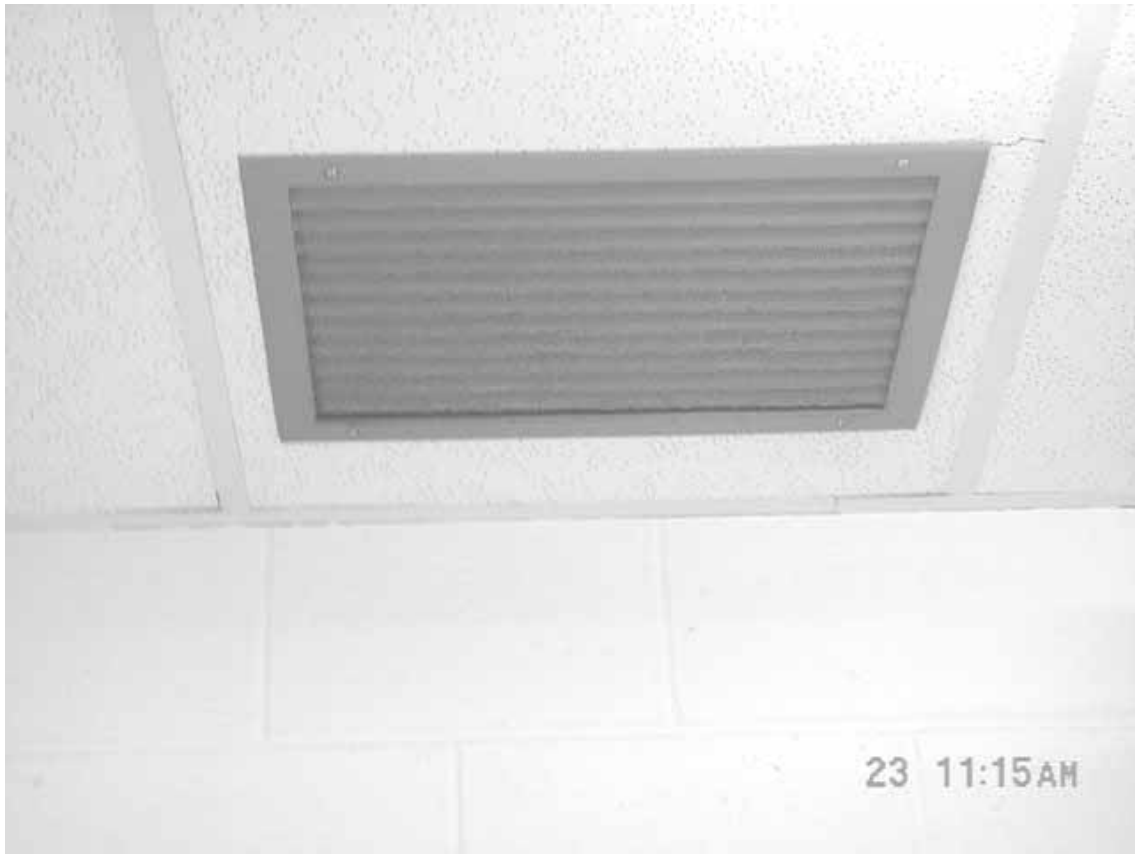
Picture 3

Exhaust ventilation in classrooms is provided by ceiling vents powered by rooftop motors (Pictures 3 and 4). The majority of ceiling vents throughout the building appeared to be drawing weakly or not at all, which can indicate that motors were deactivated or non-functional. MDPH staff observed exhaust motors on the roof and found a number of them deactivated or not operating. In some science classrooms, exhaust vents are not located in classrooms but are located in the ceiling of adjacent storerooms. Exhaust ventilation is provided by drawing classroom air through a passive door vent into the storeroom (Picture 5).

Classroom Exhaust Vent

3. Inspect exhaust motors and belts for proper function. Repair and replace as necessary.
4. Ensure univents and exhaust vents remain free of obstruction to ensure adequate airflow.

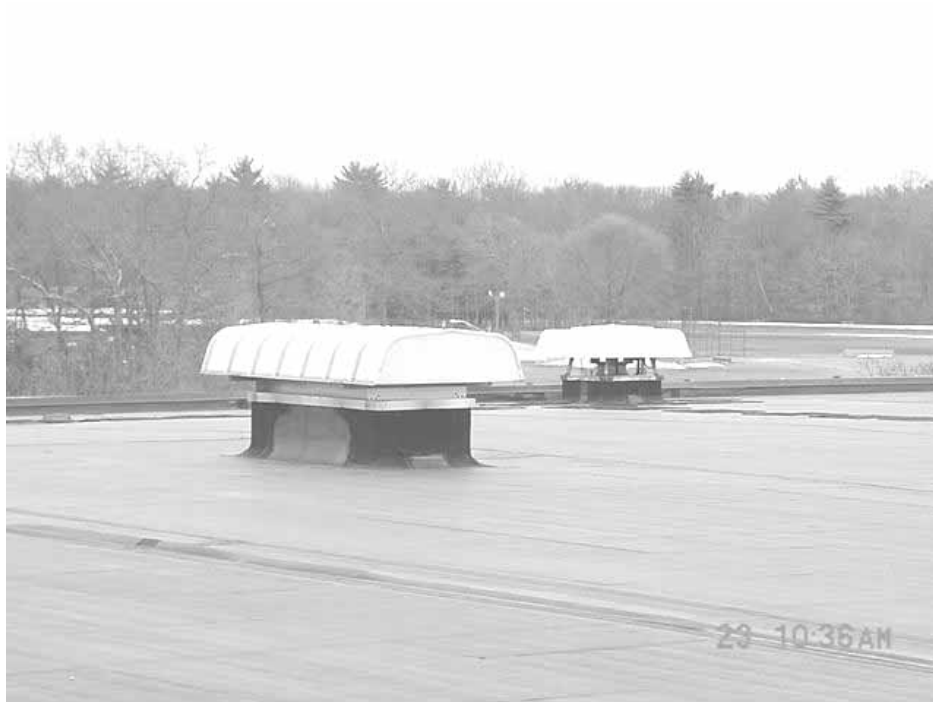
Picture 4

Rooftop Exhaust Motors

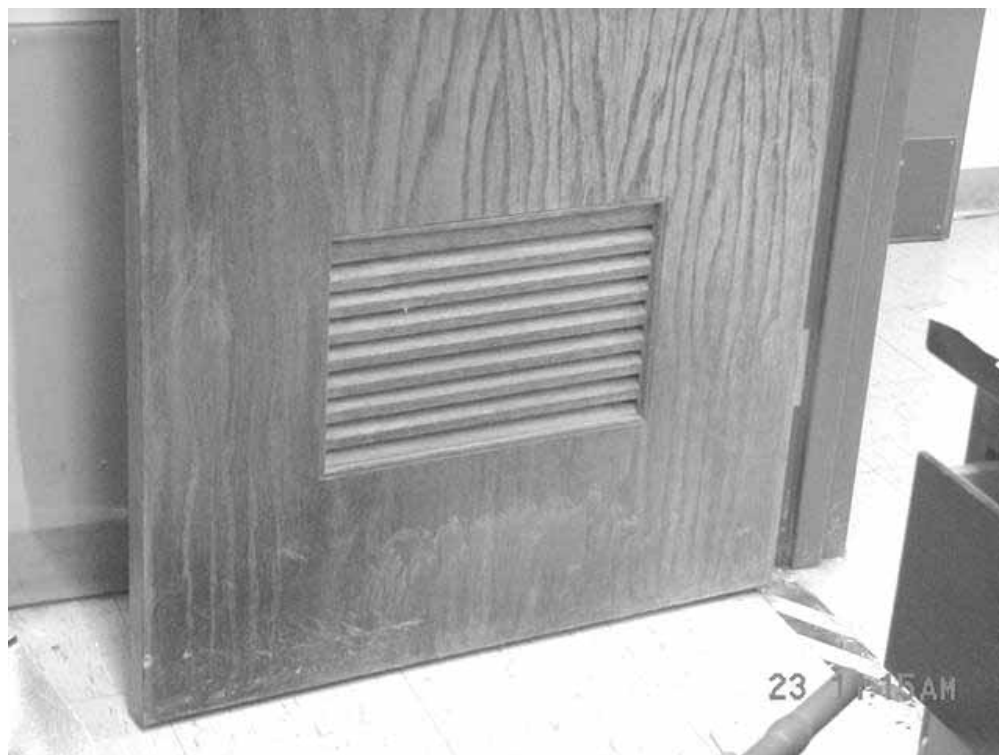
Picture 5

Passive Door Vent in Science Classroom

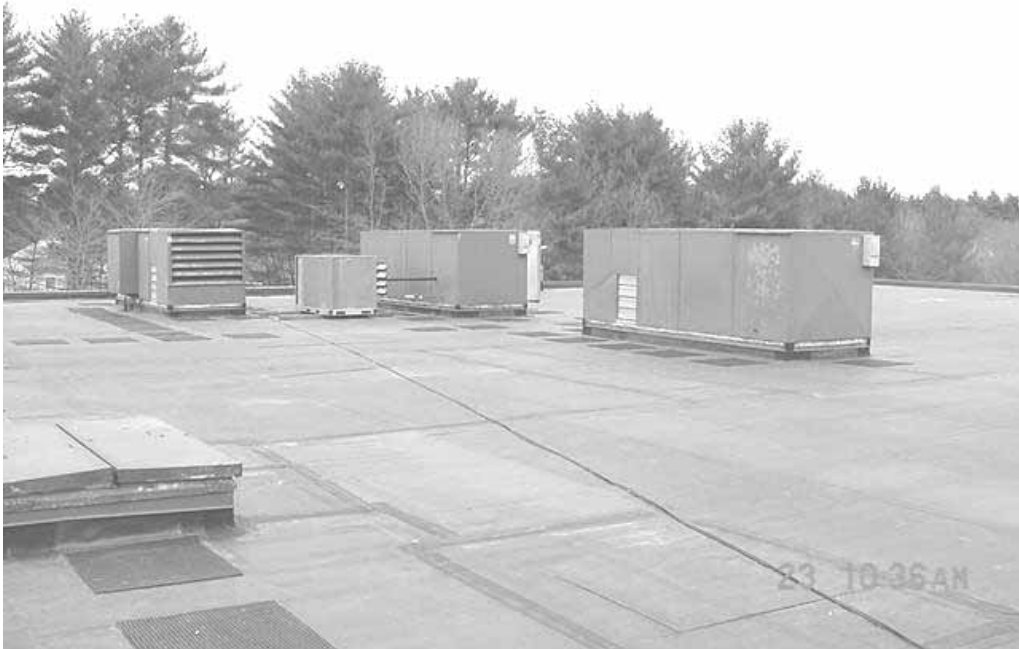
Picture 6

Mechanical ventilation in interior classrooms, and common areas such as the cafeteria, auditorium, library and gym, is provided by rooftop air handling units (AHUs) (Picture 6). Fresh air drawn into outside air intakes and is distributed via ductwork connected to ceiling mounted air diffusers (Picture 7). Exhaust ventilation is provided by ceiling-mounted exhaust grills that are ducted back to AHUs. These AHUs were operating during the assessment.

Rooftop Air Handling Units

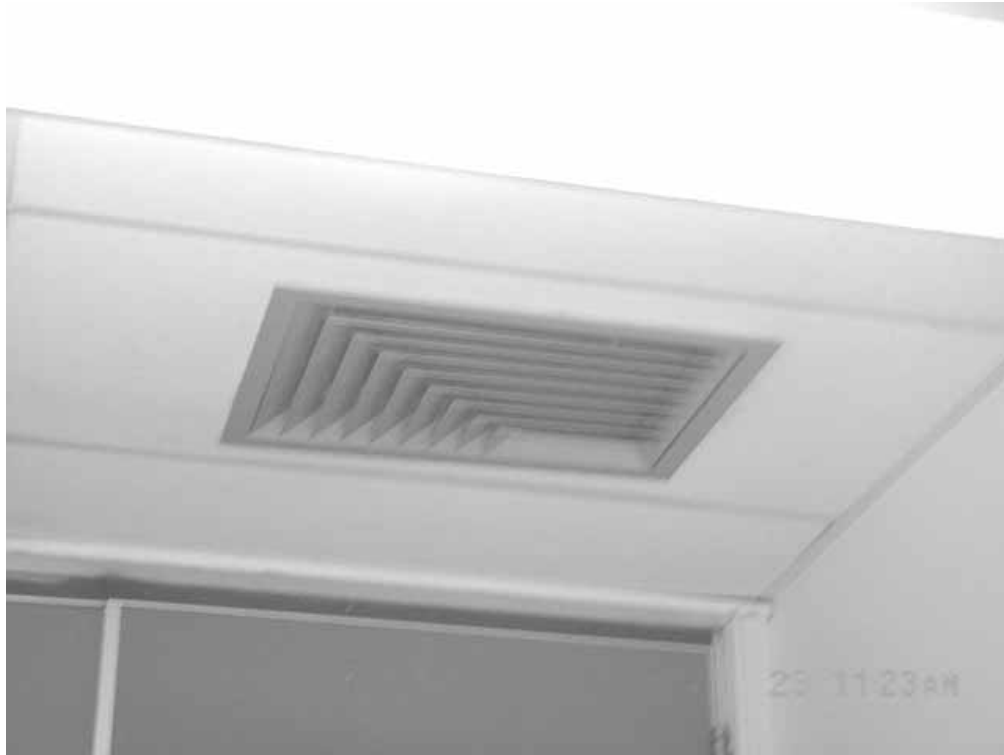
Picture 7

Ceiling-Mounted Air Diffuser

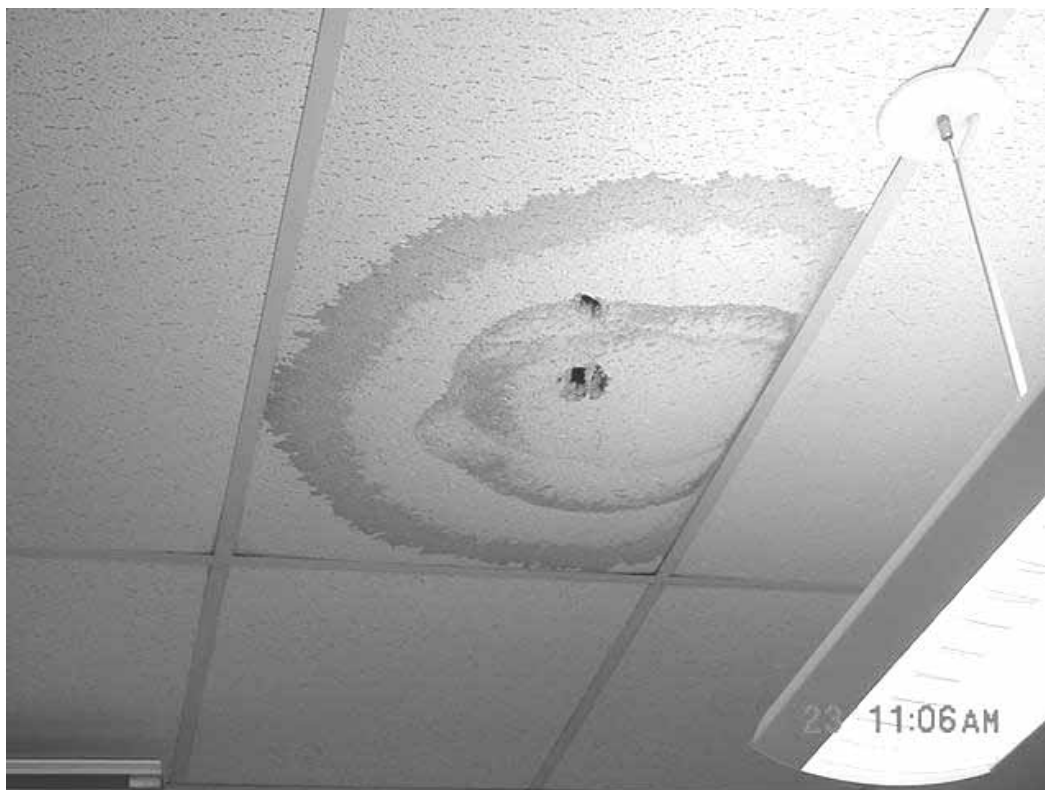
Picture 8

A large number of areas (e.g., classrooms, hallways, offices) had water-stained ceiling tiles, which can indicate leaks from the roof or plumbing system (Picture 8). The building has a history of roof leaks and still experiences periodic leaking. School maintenance personnel reported that attempts are made to make repairs (i.e. patches) as needed to prevent water infiltration. Water-damaged ceiling tiles can provide a source for mold and should be replaced after a water leak is discovered and repaired.

Water Damaged Ceiling Tile

9. Continue working with a roofing contractor to identify and make roof repairs as needed to prevent further water penetration.
10. Ensure leaks are repaired, and replace water damaged ceiling tiles. Examine the area above and around these areas for mold growth. Disinfect areas of water leaks with an appropriate antimicrobial.

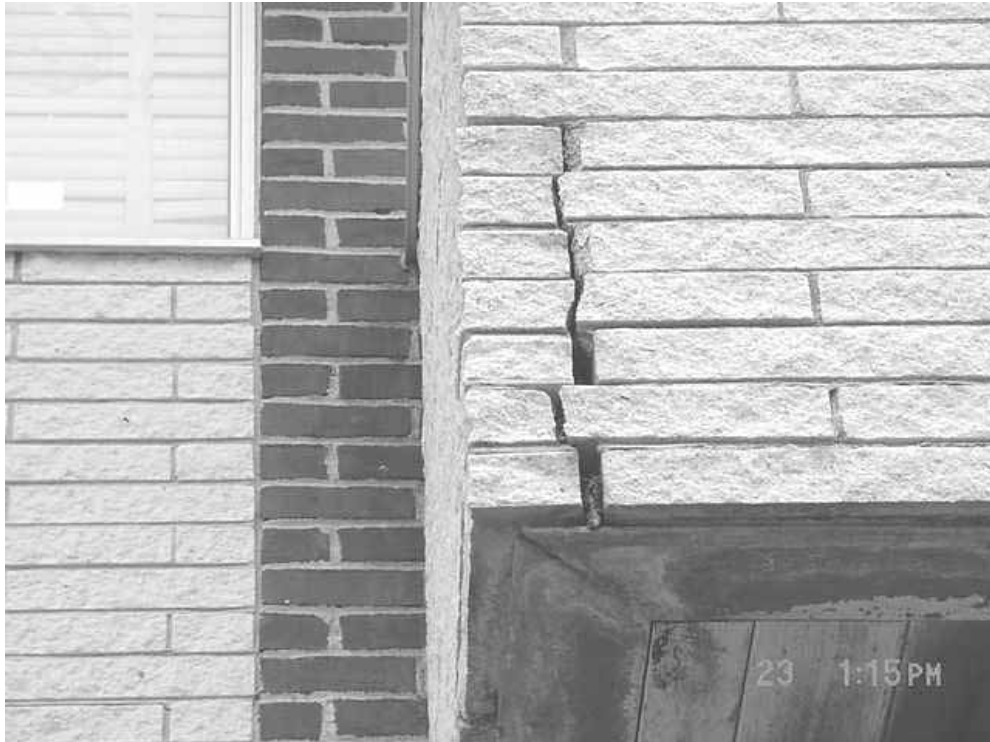
Picture 9

Mortar was missing or crumbling from the exterior walls of the greenhouse (Picture 9). These conditions are breaches of the building envelope and can provide a means for water entry into the building. Several other breaches around the perimeter of the building were seen, such as holes around local exhaust vents (Picture 10) and portions of missing or damaged expansion joint (Picture 11). Repeated water penetration can result in the chronic

Missing/Damaged Brick/Mortar on Greenhouse

11. Contact a masonry firm or general contractor to repair holes/breaches in exterior walls to prevent water penetration, drafts and pest entry. Ensure all leaks are repaired. Once leaks are repaired, replace/repair any water-damaged building materials.

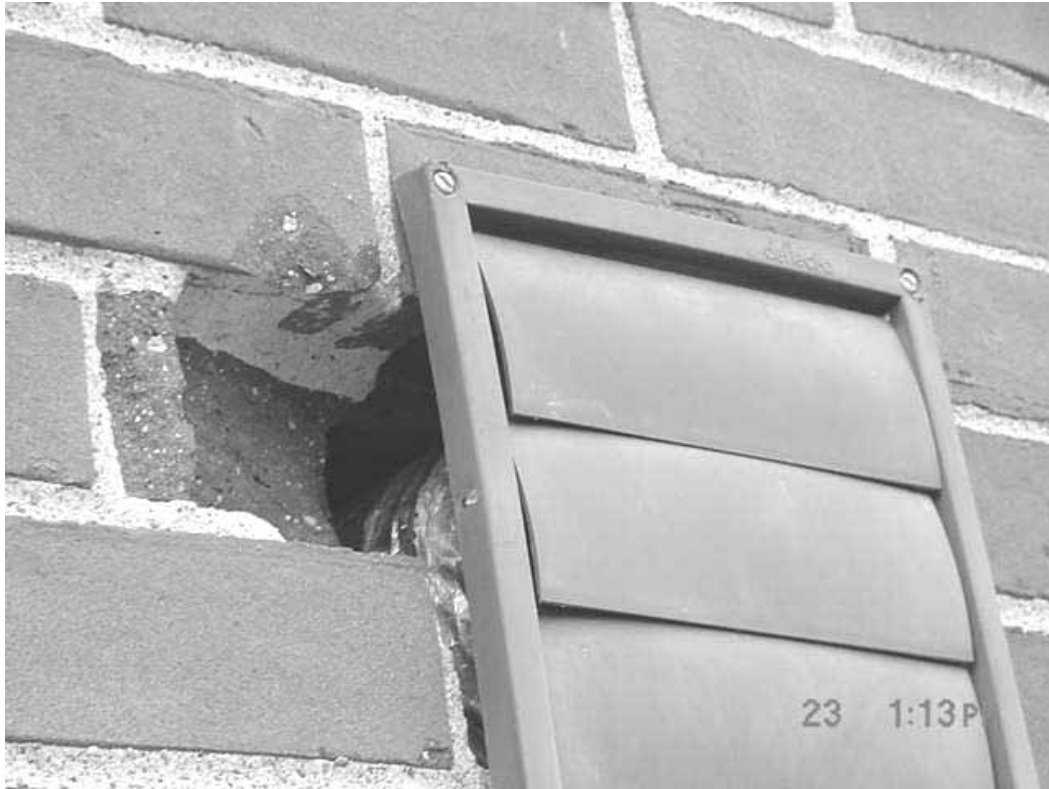
Picture 10

Hole around Local Exhaust Vent on Rear Exterior Wall of NHS

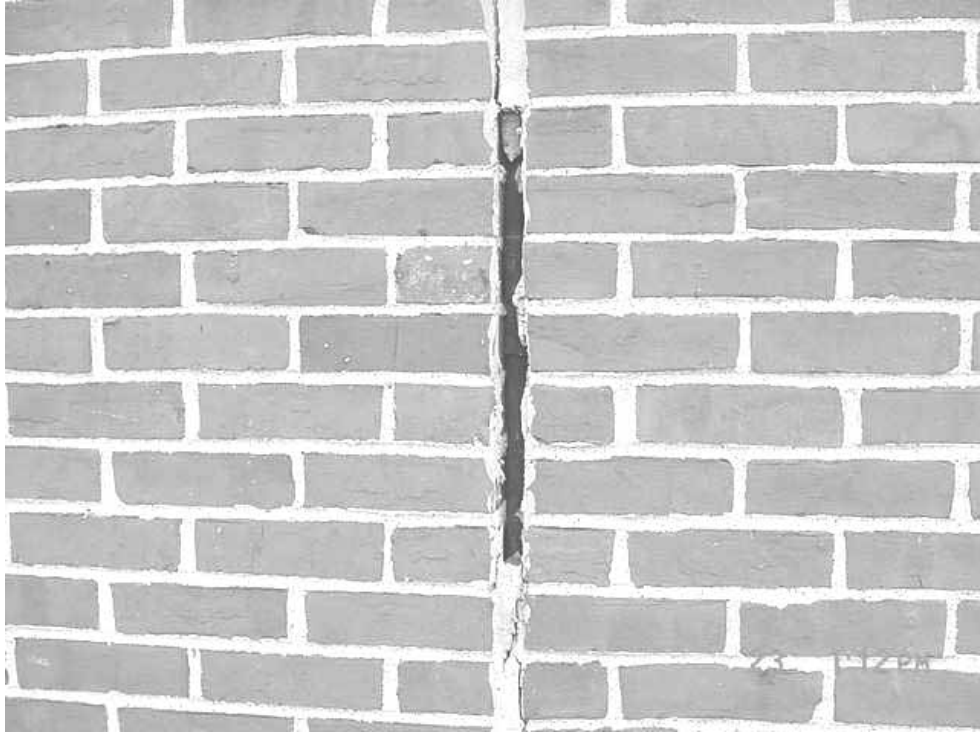
Picture 11

Missing/Damaged Expansion Joint Sealant

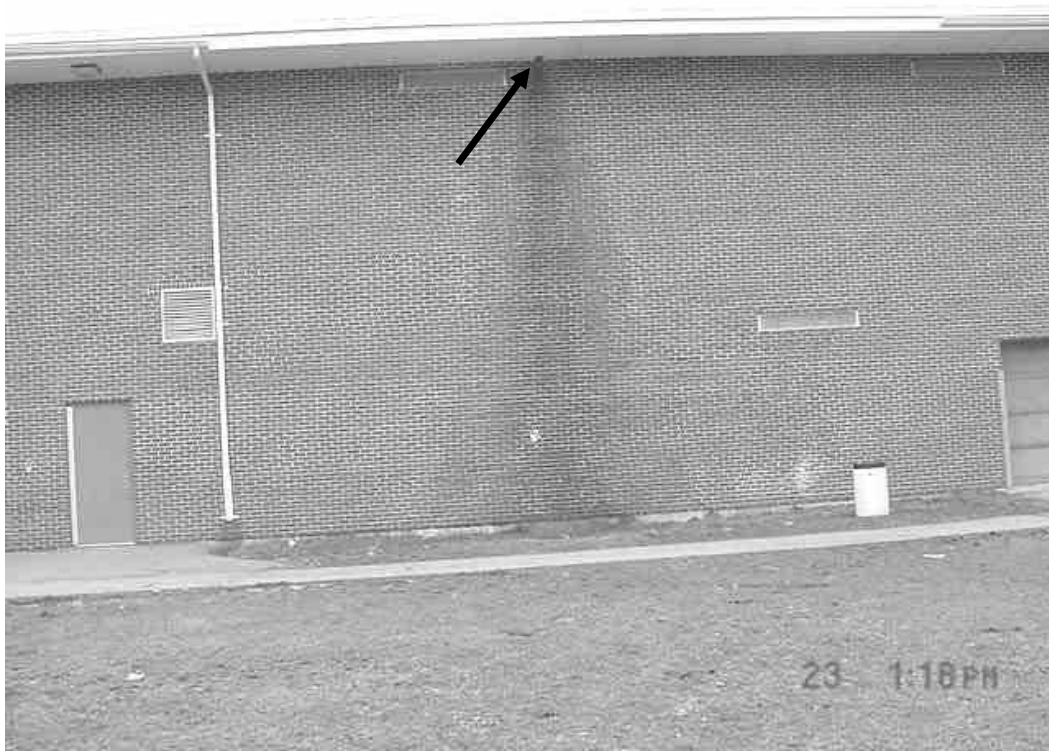
Picture 12

The gutter/downspout system was damaged/missing in several areas, and sections of the exterior wall were saturated with moisture (Pictures 12 and 13). Excessive exposure of exterior brickwork to water can result in structural damage. Over time, these conditions can undermine the integrity of the building envelope and provide a means of water entry into the building through capillary action through foundation concrete and masonry (Lstiburek & Brennan, 2001).

Missing Downspout, Note Characteristic Staining Pattern on Brickwork

12. Repair/replace elbow extensions on downspouts to direct rain water away from the building.
13. Ensure plants have drip pans. Examine drip pans periodically for mold growth and disinfect with an appropriate antimicrobial where necessary. Keep plants away from the air stream of univents.

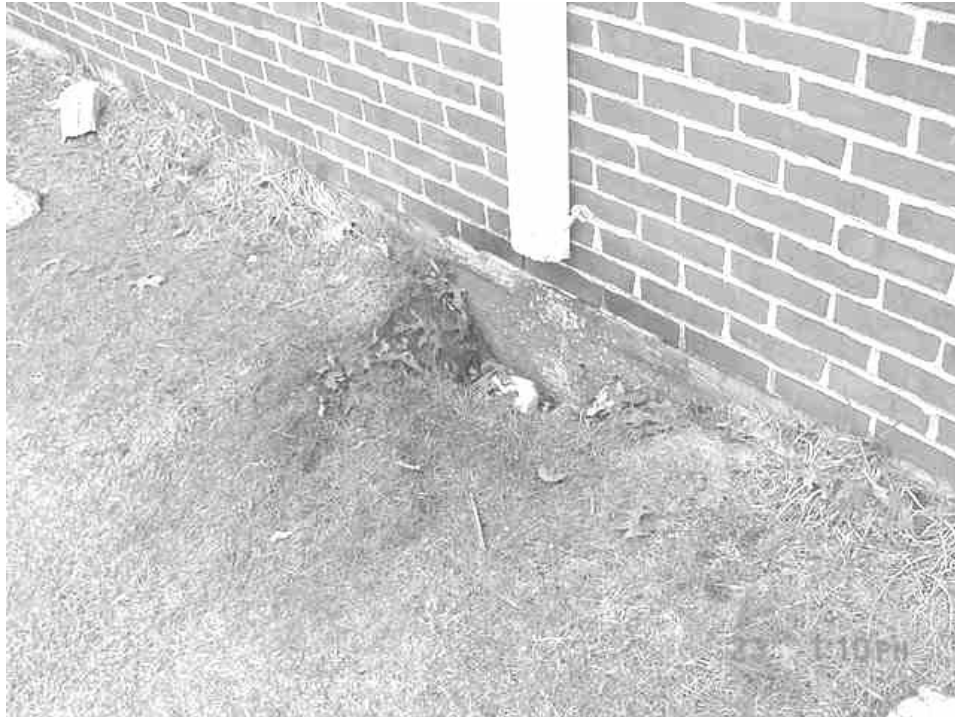
Picture 13

Missing Elbow Extension, Note Hole below Downspout Where Water Pools against the Foundation

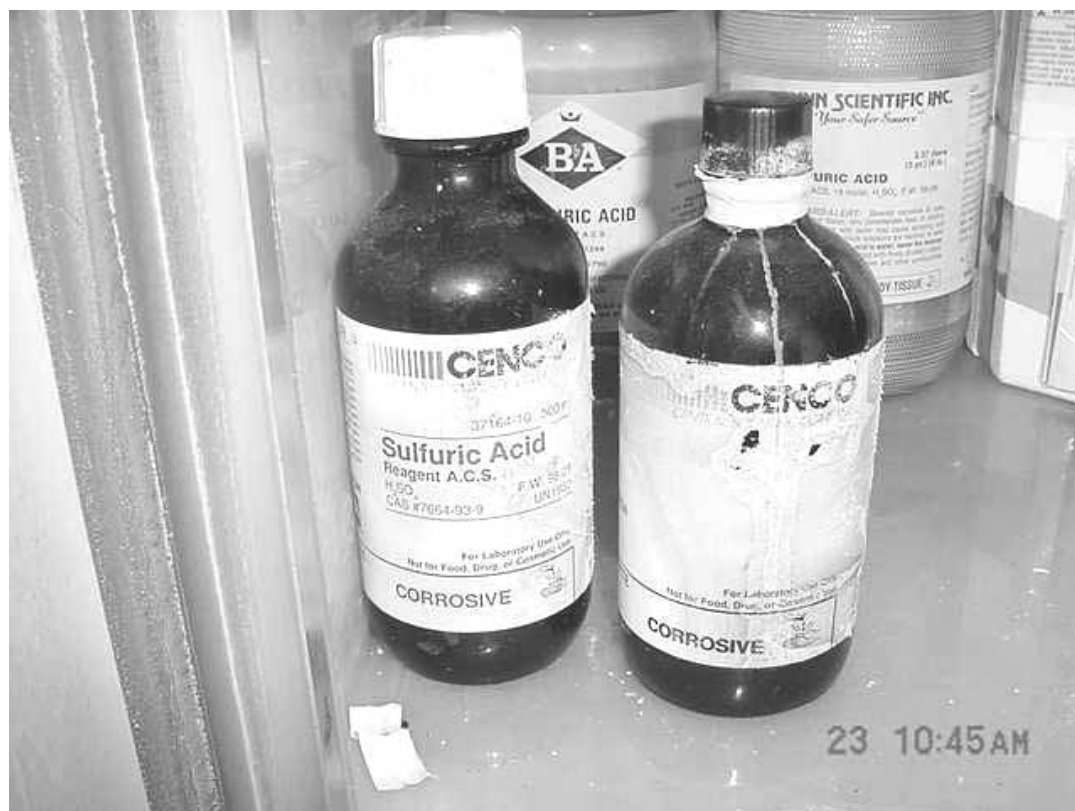
Picture 14

- Acid bottles appeared leaking with crystallized material on the outside of bottle; some labels also appeared corroded, making identification difficult (Picture 14).
- Doors of the storage locker did not close properly (Picture 15).
- Items were labeled with chemical formula instead of the chemical name (Picture 16).
- Some items were missing labels (Picture 17).

Crystallized bottle of Acid, Note Corrosion on Bottle Making Identification Difficult

14. Conduct a chemical inventory in all storage areas and classrooms. Discard hazardous materials or empty containers of hazardous materials in a manner consistent with environmental statutes and regulations. Follow proper procedures for storing and securing hazardous materials. Obtain Material Safety Data Sheets (MSDS') for chemicals from manufacturers or suppliers.

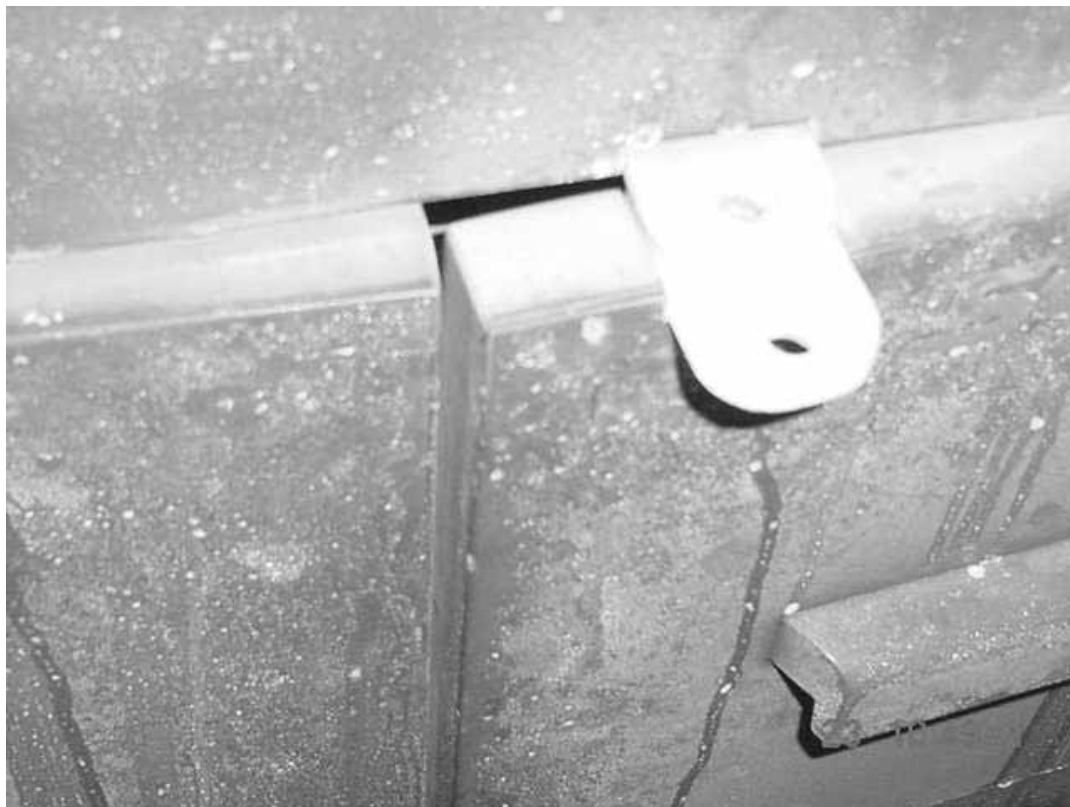
Picture 15

Close-up of Acid Storage Locker Doors That do Not Stay Closed

15. Make repairs or take measures to secure the doors to the acid storage cabinet in the chemistry storeroom.
16. Maintain MSDS' and train individuals in the science department in the proper use, storage and protective measures for each material in a manner consistent with the Massachusetts Right-To-Know Law, M.G.L. c. 111F (M.G.L., 1983).

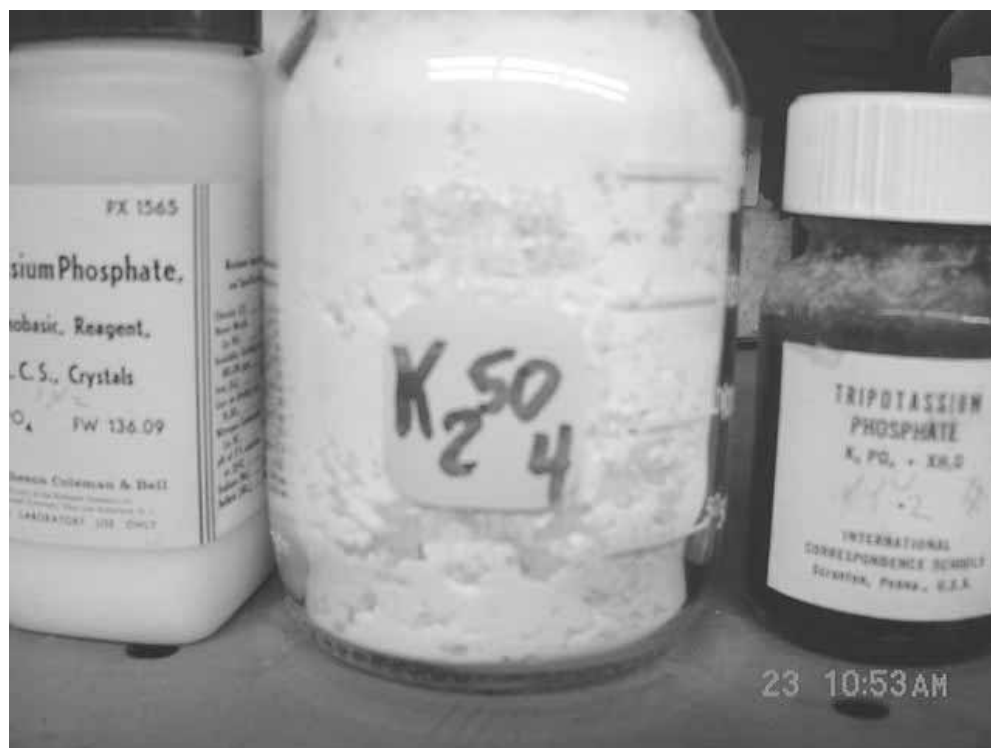
Picture 16

Container Labeled With Chemical Formula

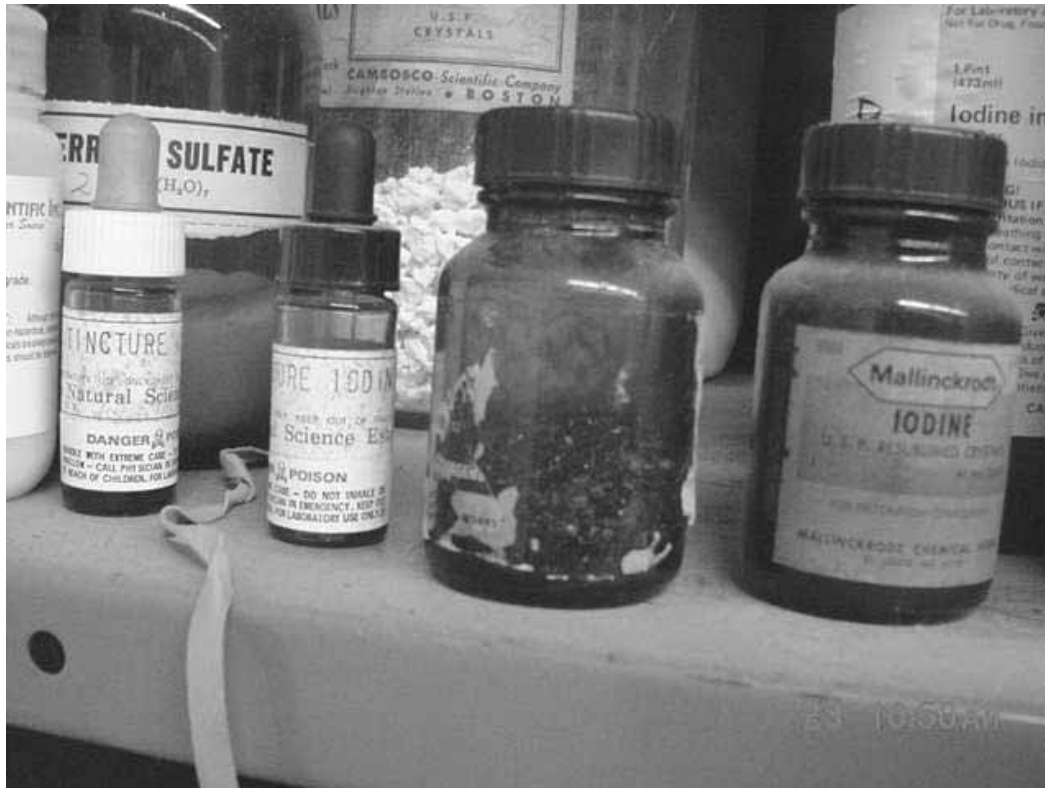
Picture 17

Container with Missing Label

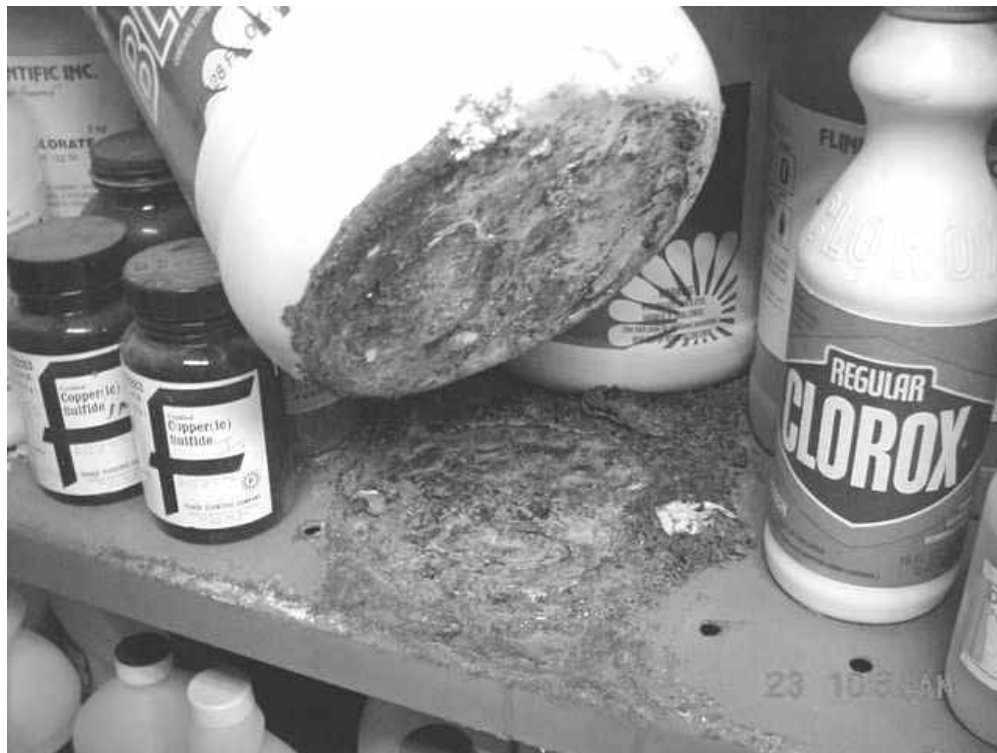
Picture 18

- Unidentified materials appeared to have leaked onto metal shelving, causing corrosion. Leaked material also appears to have dripped onto materials directly below (Pictures 18 and 19).
- Guardrails did not exist on the edge of shelves to prevent containers from accidentally slipping from shelves.

Leaking Material Causing Corrosion of Metal Shelving

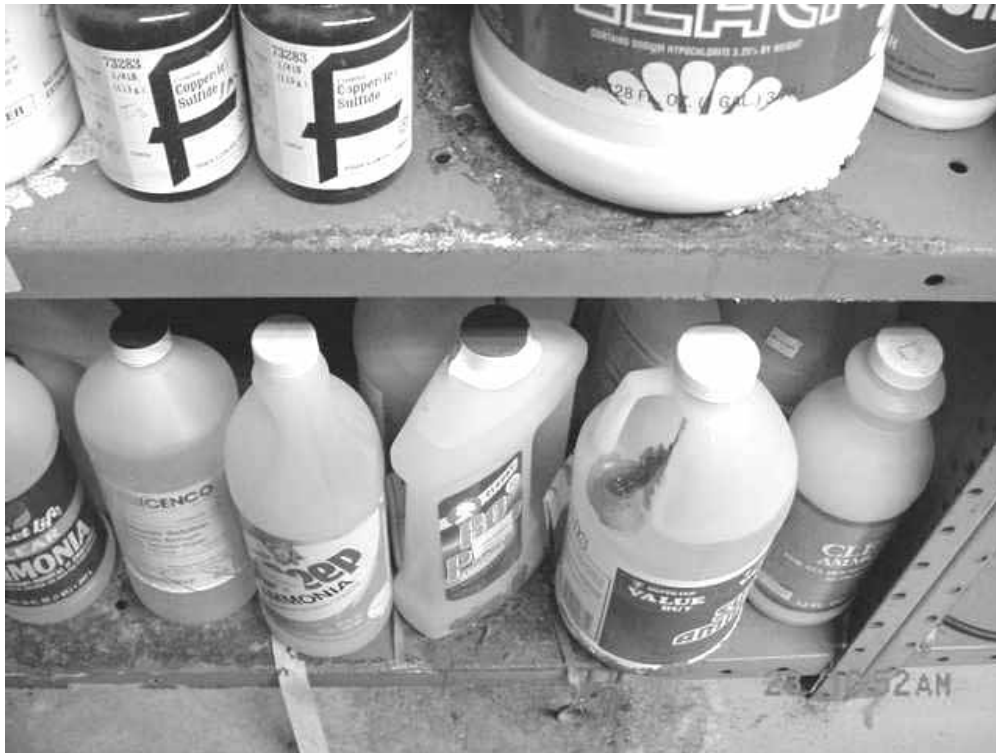
Picture 19

Leaking Material Causing Corrosion of Metal Shelving and Dripping onto Shelving/Materials below

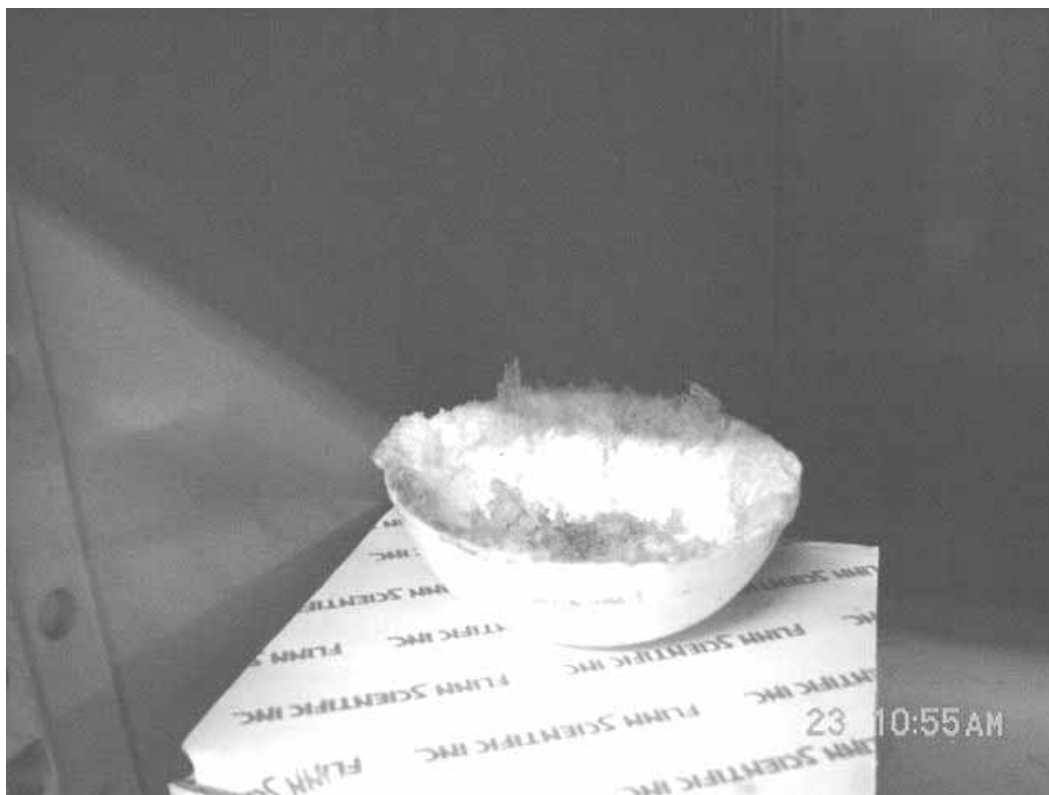
Picture 20

Crucible with Unidentified Crystallized Material on Open Shelf

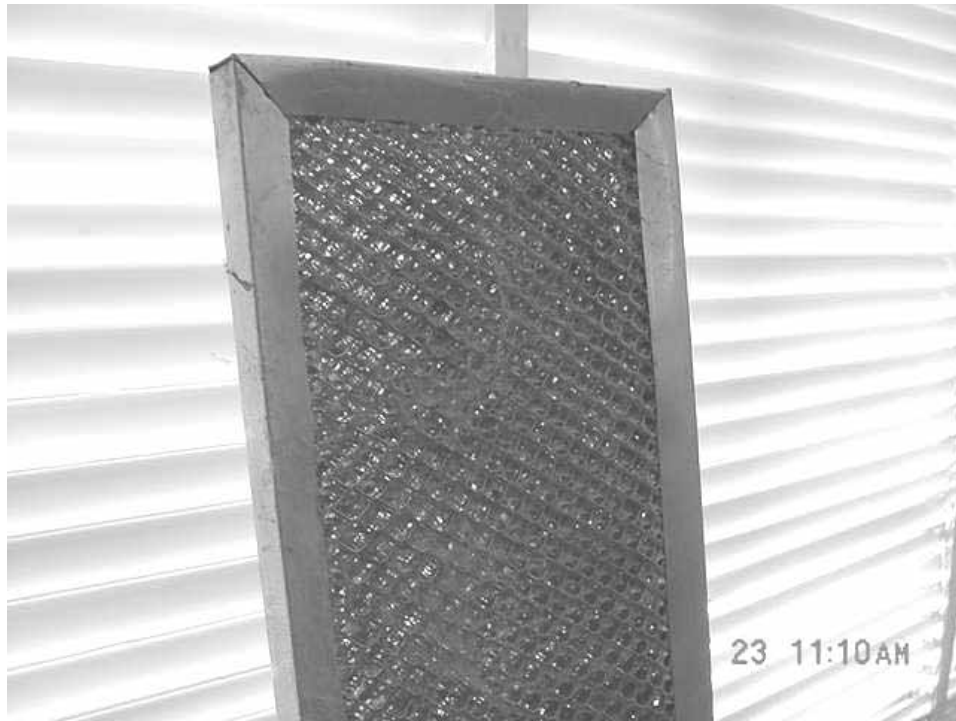
Picture 21

A number of other conditions that can affect indoor air quality were noted during the assessment. Older model univents appear to be equipped with metal mesh filters that provide

minimal filtration of respirable particulates (Picture 21). In order to decrease aerosolized particulates, disposable filters with an increased dust spot efficiency can be installed in these units. The dust spot efficiency is the ability of a filter to remove particulates of a certain diameter from air passing through the filter. Filters that have been determined by ASHRAE to meet its standard for a dust spot efficiency of a minimum of 40 percent would be sufficient to reduce airborne particulates (Thornburg, D., 2000; MEHRC, 1997; ASHRAE, 1992). Note that increased filtration can reduce airflow produced by the unit by increased resistance; this condition is known as pressure drop. Prior to any increase of filtration, each univent should be evaluated by a ventilation engineer to ascertain whether they can maintain function with more efficient filters. The univent in the wood shop is located directly under the wood dust collector (Picture 22). This configuration can result in the draw of aerosolized dust into the univent and subsequent distribution throughout the room. In addition, the accumulation of wood dust in heating components may pose a fire hazard.

Metal Mesh Filters in Univents

18. Consider replacing metal filters in older model univents with disposable filters.
19. Consider increasing the dust-spot efficiency of HVAC filters. Prior to any increase of filtration, each piece of air handling equipment should be evaluated by a ventilation engineer as to whether it can maintain function with more efficient filters.

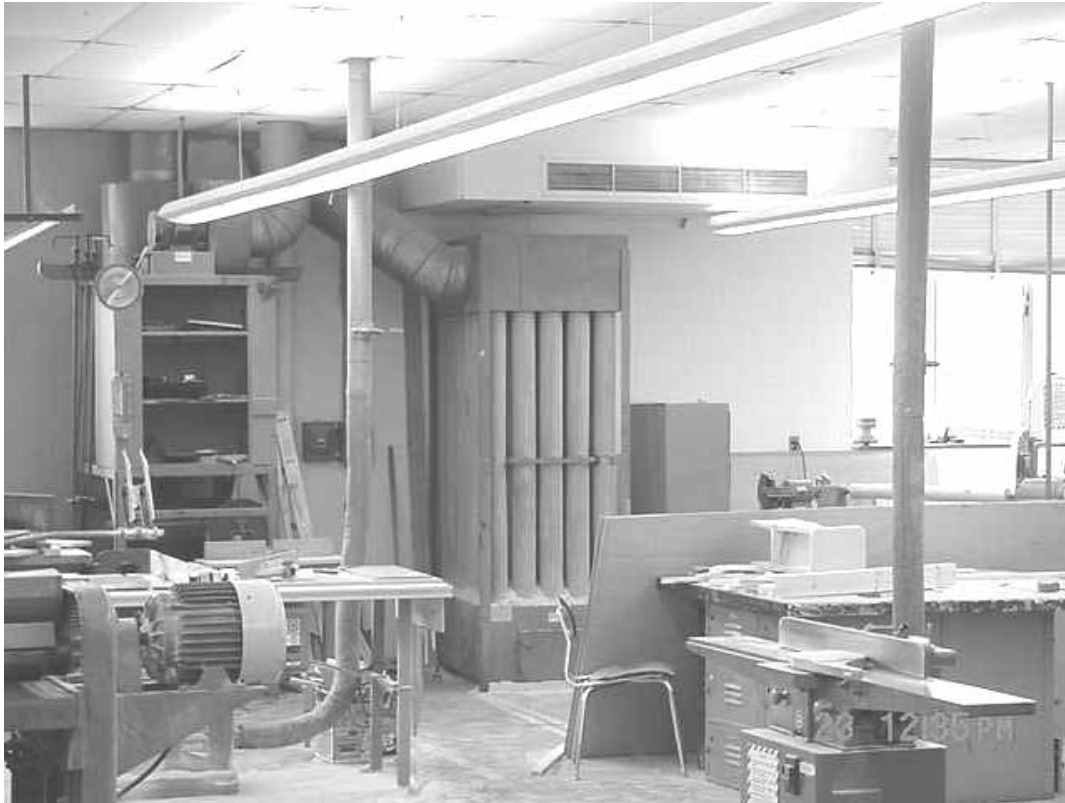
Picture 22

Wood Dust Collection Unit Directly beneath Ceiling-Mounted Univent

17. Change filters for all air-handling equipment as per the manufacturer's instructions or more frequently if needed. Vacuum interior of units prior to activation to prevent the aerosolization of dirt, dust and particulates. Ensure filters fit flush in their racks with no spaces in between allowing bypass of unfiltered air into the unit. Particular attention should be made to the univent in the wood shop.
